# Study of Causes of Potholes on Bituminous Roads –A Case Study

The study analyzes pothole problem on the roads of Chandigarh and its causes for assessing the riding quality. In the present work various problematic areas are taken into account to assess the causes of pothole formation and adopt the long lasting solution to tackle the problem to prevent the deterioration of road surfaces.

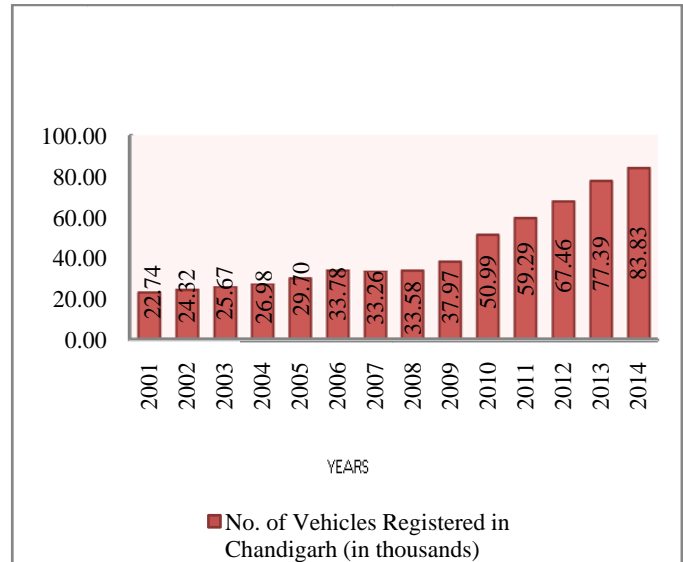
Fig. 1: Graphical Representation of Growth of vehicles

It is clear from above graph that the trend of registered vehicles in the city is gradually increasing. As the number of vehicles registrations has increased, the traffic on roads has increased which has led to the excessive load on the pavement surface ultimately causing its deterioration and thus formation of pothole takes place.

Chandigarh with its high population growth rate, coupled with high economic growth rate has resulted in ever increasing demand for vehicles creating excessive pressure on the city's existing transport infrastructure. Fig. 2 below, shows how the traffic has increased in last 14 Years.

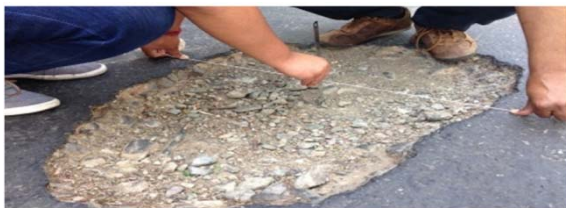
A pothole is generally a bowl - shaped hole in the pavement surface having minimum width of 6". The severity of potholes may be defined depending on their depth as follows:-

- Low – severity potholes are less than 1" deep.
- Moderately severe from 1"- 2" deep.
- High – severity greater than 2" deep.

Fig. 2: Showing Depth of Pothole

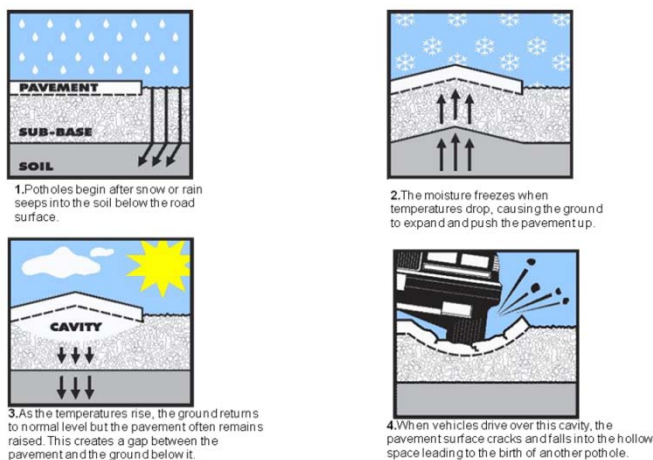
The formation of potholes is exacerbated by low temperatures, as water expands when it freezes to form ice, and puts greater stress on an already cracked pavement or road. Once a pothole forms, it grows through continued removal of broken chunks of pavement. If a pothole fills with water the growth may be accelerated, as the water "washes away" loose particles of road surface as vehicles pass. Potholes can grow to feet in width, though they usually only become a few inches deep, at most. If they become large enough, damage to tires and vehicle suspensions occurs. Serious road accidents can occur as a direct result, especially on motorways where vehicle speeds are greater.

Fig. 3: Formation of a Pothole

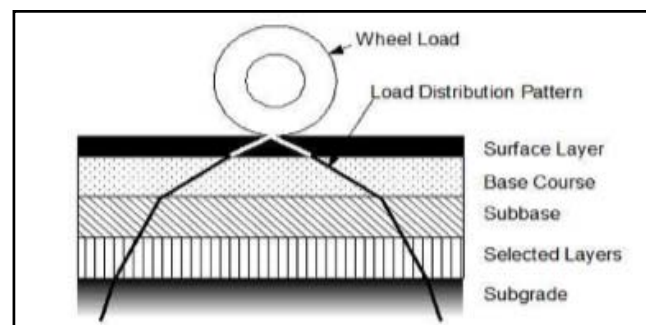
Fig. 4: Load Distribution of Flexible Pavement

The strongest material (least flexible) is in the top layer and the weakest material (most flexible) is in the lowest layer. The reason for this is that at the surface the wheel load is applied to a small area, the result is high stress levels, deeper down in the pavement, the wheel load is applied to larger area, and the result is lower stress levels thus enabling the use of weaker materials.

Flexible pavements are constructed of several layers of natural granular material covered with one or more waterproof bituminous surface layers, and as the name imply, are considered to be flexible. A flexible pavement will bend under the load of a tyre. In flexible pavements, as shown in Fig. 4 the load distribution pattern changes from one layer to another, because the strength of each layer is different.

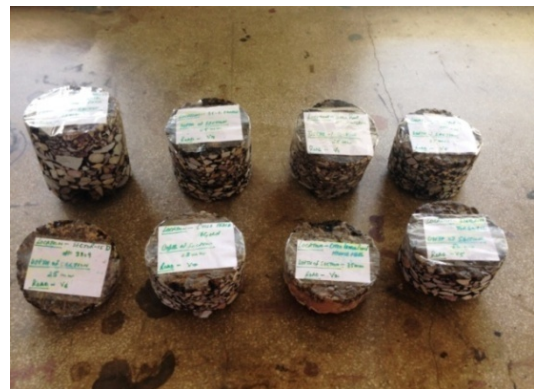
Once the roads are selected after visual examination, the selected sample of road is collected for checking the bitumen content and carrying gradation test to identify the cause of occurrence of pothole. The samples are collected using core cutter alongside the pothole to examine the samples in the laboratory. The core sample is removed using the core retrieval unit and the core samples are immediately wiped dry and the identification number is marked.

**Fig. 5: Road Samples Collected Using Core Cutter**

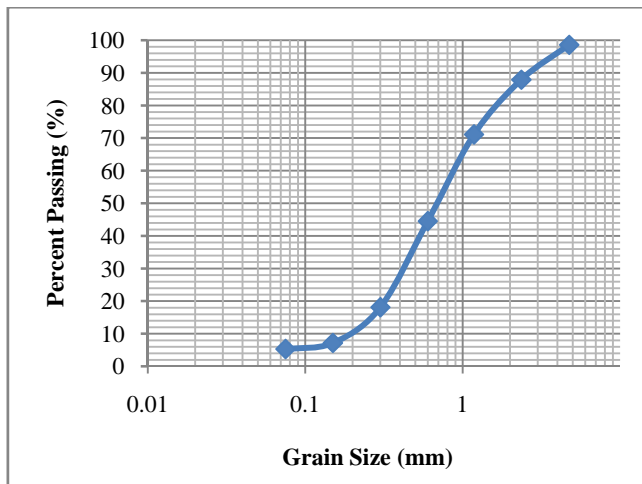
Graph 1: Grain Size Distribution Curve (V1 Road)

→ From grain size distribution curve:

- % Gravel = 1.4
- % Sand = 93.3
- $D_{30} = 0.399$  mm
- % Fines = 5.3
- $D_{60} = 0.91$  mm
- $C_u = 4.992$
- $C_c = 1.037$

The gradation test carried out shows that the coarse grained aggregate in the mix is well graded gravel. The permeability of the mix will be high as it is GW. Therefore the ingress of water may take place at a higher rate.
