# Outstanding Structure: The Leaning Tower Of Pisa

**Abstract :** The Leaning Tower of Pisa is the most famous example of soil related problems from this era. Its stabilization process proved to be one of the greatest challenges faced by the civil engineers and architectural conservationists. This paper aims at giving information about the tower itself, its construction and the underlying geology. The paper also discusses the history of the tilting and describes the temporary remedial measures undertaken and permanent stabilization proposed.

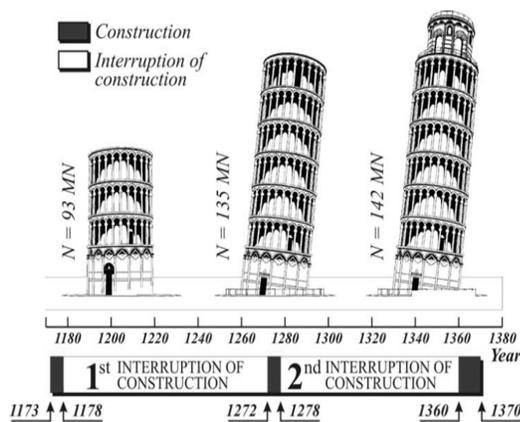
**Fig. 2:** History of Construction (Adapted from Burland J.B. et al 2009)

Construction of the tower occurred in three stages across 199 years (as shown in the Fig.2). Work on the ground floor of the white marble campanile began in 1173, during a period of military success and prosperity. This ground floor is a blind arcade articulated by engaged columns with classical Corinthian capitals.

The tower began to sink after construction had progressed to the third floor and beyond in 1178. This was due to a mere three-metre foundation, set in weak, unstable subsoil, a design that was flawed from the beginning. Construction was subsequently halted for almost a century because of Pisa's wars with its neighbouring city, Florence. This allowed time for the underlying soil to settle. The construction was resumed in 1272 under Giovanni di Simone, architect of the Camposanto.

The architect took notice of the lean in 1185, so the builders accommodated the tilt by adding extra height to the upper stories on one side of the Tower. Because of this, the tower is actually curved [6]. The extra weight caused the upper part of the Tower to lean in the opposite direction. Construction was again halted in 1284, when the Pisans were defeated by the Genoans in the Battle of Meloria.

The seventh floor was completed in 1319. It was built by Tommaso di Andrea Pisano, who succeeded in harmonizing the Gothic elements of the bell-chamber with the Romanesque style of the tower. The bell-chamber was finally added in 1372. There are seven bells, one for each note of the musical major scale. The largest one was installed in 1655.

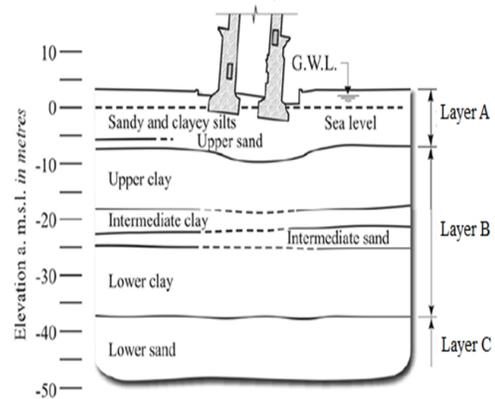
**Fig. 3:** Soil Profile (Adapted from Burland J.B. et al 2009)

The ground underlying the Leaning Tower of Pisa consists of three distinct layers (as shown in Fig.3). Layer A, about 10 m thick, composed of soft sandy and clayey silt deposits laid down in shallow water (lagoonal, fluvial and estuarine conditions) less than 10,000 years ago. Layer B, which extends to a depth of 40 m, consists of very soft sensitive normally consolidated marine clays laid down up to 30,000 years ago. This stratum is laterally very uniform and due to its high sensitivity, loses much of its strength if disturbed. Layer C, extending to a depth of 60 m, is dense marine sand. The water table in Layer A is between 1 m and 2 m deep. The soil borings done around and beneath the Tower shows that the contact between the Layer A and the marine clay of Layer B is dish-shaped, due to the weight of Tower. This indicates that the average settlement of the Tower is between 3.0 m to 3.5 m, which shows high compressibility of the underlying soil [7].
